**AGENDA
CITY OF STURGEON BAY
WATERFRONT REDEVELOPMENT AUTHORITY**

STRUCTURAL CONDITION ASSESSMENT REPORT FOR
THE GRANARY ELEVATOR BUILDING
PHASE II – FOUNDATION EVALUATION
Sturgeon Bay, Wisconsin
MBJ Commission No. W13-314.1

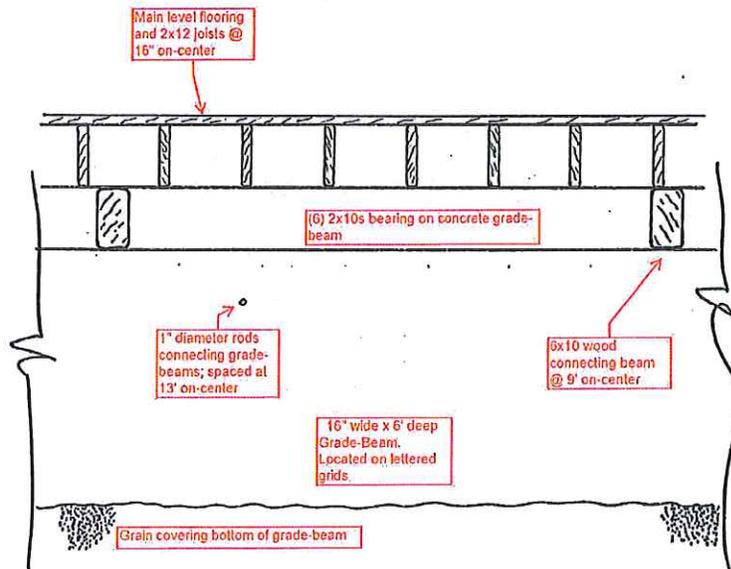
Diagram 2: Elevation of a grade-beam

The July observations created the perception that relatively shallow grade-beams supported the building, and that a shallow crawlspace existed in the northwest corner of the building. The recent site visit uncovered that this is not the case. The foundation consists of 16" wide by 6'-0" deep concrete grade-beams that lie on the north/south lettered grids. A composite 12x10 wood beam (six 2x10s) bears on the grade-beam; 2x12 wood floor joists spaced at 16" on-center span across the composite beam. The building columns bear atop the grade-beams; it is not clear whether the columns bear directly on the concrete or sit atop the 12x10 wood beam. The grade-beams are tied together by 1" diameter rods that span east/west and are bolted to the grade-beams at approximately 9" below the top of concrete. Parallel to the rods, 6x10 wood beams spaced at 9' on-center also tie the top of the grade-beams together. See Diagram 2 and Photo 2. The grade-beams bear on wood piles driven to competent soils.

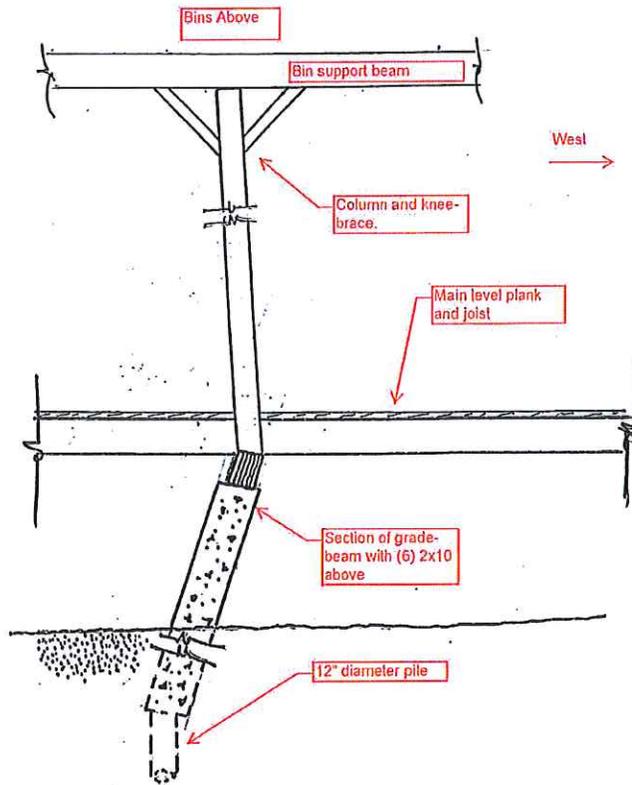
Diagram 3: Section of grade-beam

The east/west tilt of the building has caused the tops of the grade-beams to rotate several inches to the west. The extent of deflection varies across the building. The outside grade-beams (on grids A and E) are sloped only a few inches, while the interior grade-beams have greater deflections. The north and south ends of the interior grade-beams (B-D) are separated from the middle 18' of the beams, near grids 3 and 5, by a construction joint. The grade-beams between the joints are rotated approximately 21" to the west (16 degrees); the grade-beams to the north and south are deflected approximately 6" to the west (5 degrees). See Diagram 3 and Photo 3.

- a. Install new concrete grade-beams on the numbered grids that tie the existing grade-beam together, and resist additional rotation. This would require 25 grade-beams (the grade-beams on grid 6 are intact); preliminary calculations indicate that these beams could be 10" wide x 30" deep beams, with (6) #5 horizontal reinforcing bars, and #3 closed stirrups spaced at 16" on-center.
- b. The second system consists of four below-grade buttresses constructed against the west face of the elevator to transfer the east/west wind forces from the foundation to the soils. These could be 10" wide x 30" deep x 36" long, and would include two battered steel helical piers (driven into the soil at an angle).

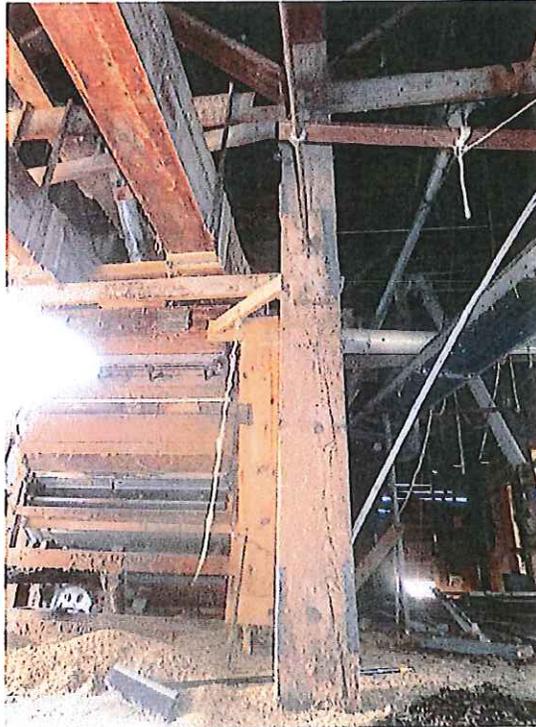
The main floor of the elevator consists of wood planks that bear on wood joists, spaced at 16" on-center. The joists bear on concrete grade-beams, located on the lettered grids. Thirty 12"x12" wood columns extend from the foundation to support the bins. The top-of-column connections include 12"x2 ½" knee-braces that provide rotational resistance. See photo 1.

Photo 1: Main level column and beams

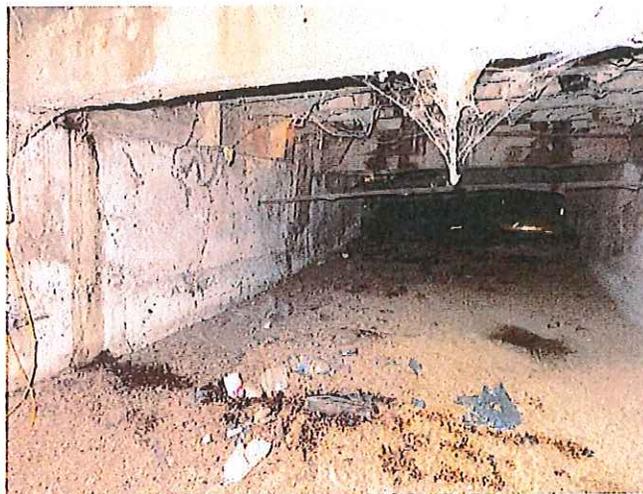
Photo 2: Foundation grade-beams & tension rod in the distance

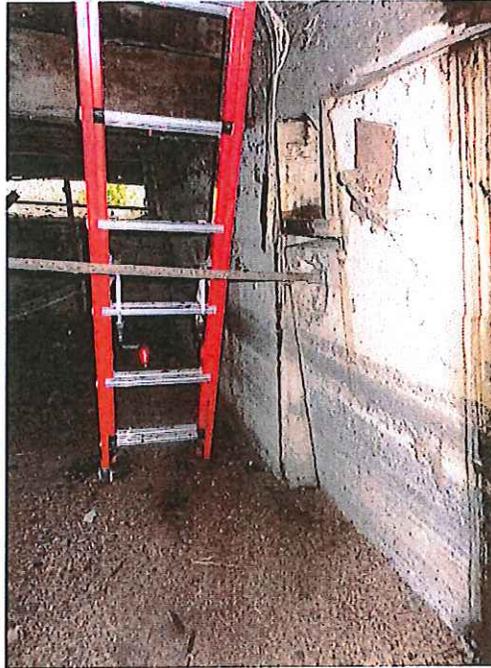
The interior grade-beams (grids A-C) are divided by construction joints at approximately 1/3 points along their length. They are rotated 15 degrees between the joints, and five degrees at the ends of the grade-beams. There is no additional damage to the grade-beams. The tops of the wood piles lie below the water-table and are not subjected to cyclical wetting and drying; therefore, there is insufficient oxygen to allow deterioration due to decay fungi or insect infestation.

Photo 3: Broken grade-beam showing 16 degree and 5 degree rotation

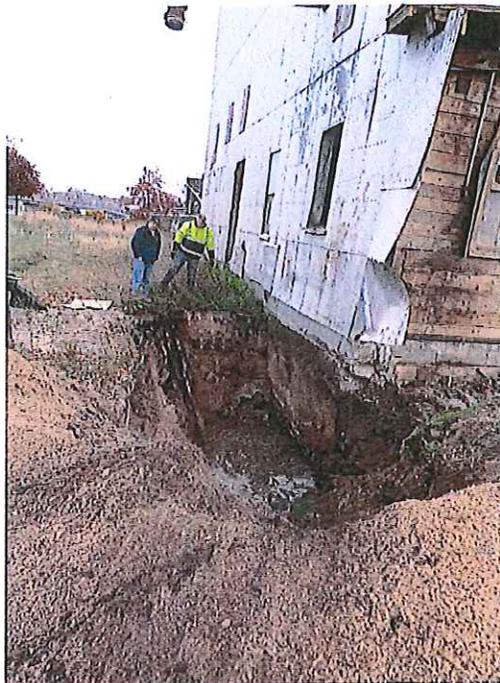
The excavation at the southwest corner of the building exposed the bottom of the westernmost grade-beam, a 5" thick wood beam beneath the grade-beam, and the top 6" of two 12" diameter wood piles. These piles are spaced 5' on-center. The wood piles lie below the water-table and are saturated with water. The excavation removed the water briefly for observation. The exposed portion of the piles were in very good condition, with no visible deterioration. See Photos 4, 5 & 6.

Photo 4: Excavation at southwest corner of elevator

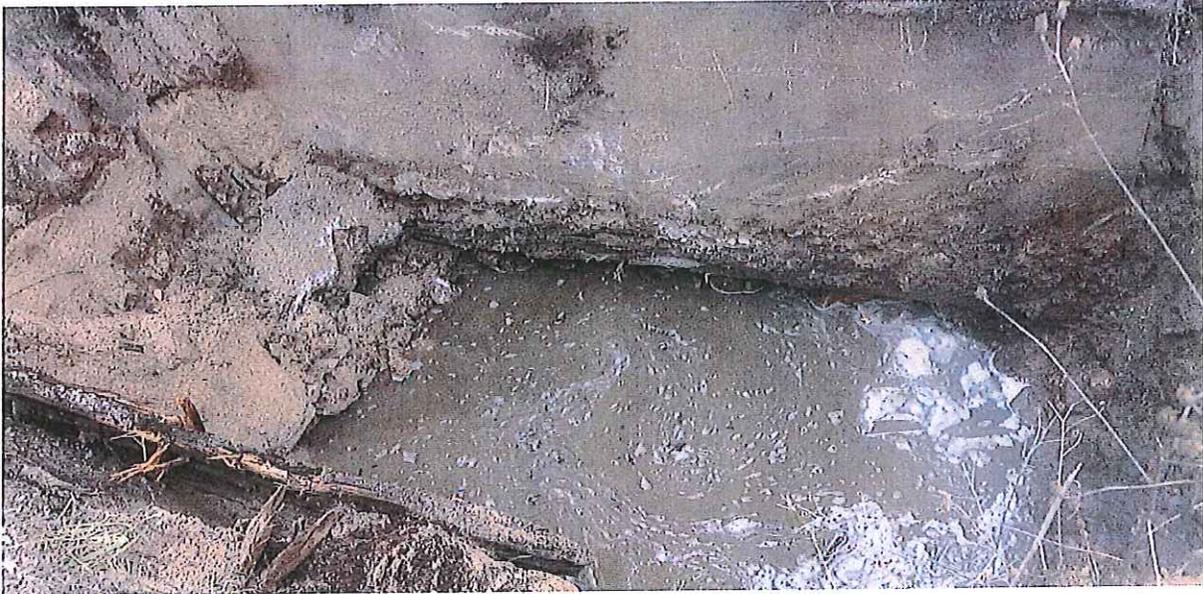
Photo 5: Excavation showing two wood piles

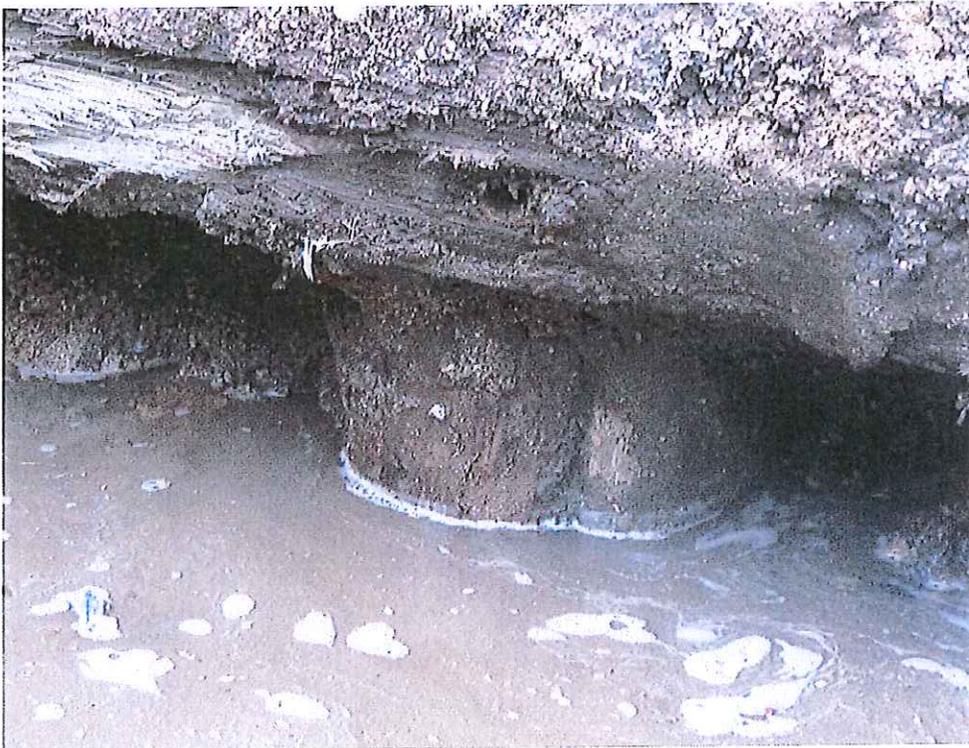
A common problem with historic buildings founded on wood piles is the deterioration of the piles due to attack by decay fungi or insect infiltration. This generally occurs near the top of the piles where the water-table rises and falls cyclically, causing periodic wetting and drying of the piles. Piles that are continuously submerged do not suffer attack due to a lack of oxygen. The excavation of the piles in the southwest corner of the elevator showed that the piles lie below the water-table; the City staff noted that the water level is at an historically low level, which confirms that the piles have remained saturated for the history of the building. This makes a strong case for no past deterioration due to decay fungi or insect attack.

Photo 6: Close-up of wood pile

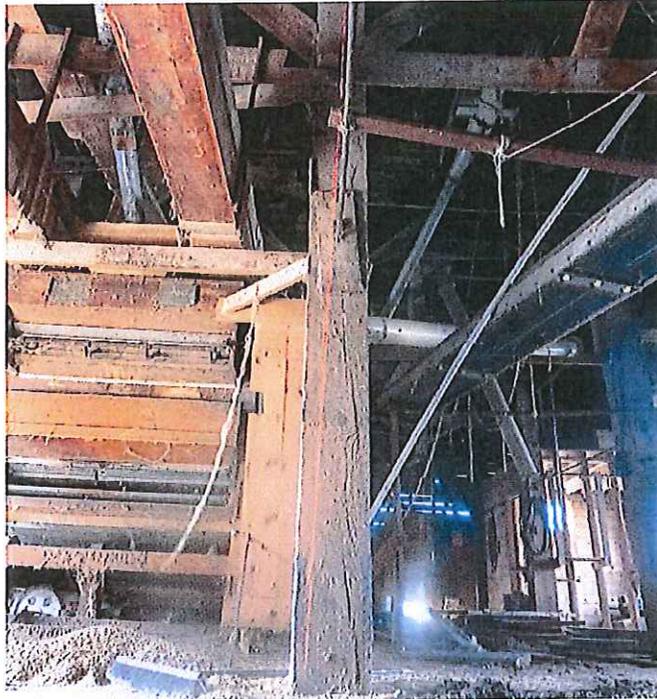
The original lateral resisting system in the 1st level was not sufficiently stiff to resist wind loads without excessive deflections. As a result, the elevator is permanently deflected to the west and to the south. The deflections are largest in the interior bays (grids B-D and 2-5). New systems are required to resist future wind loads and to address the rotational forces caused by the rotated grade-beams.

Photo 7: Interior column with laser-generated plumb-line showing westward deflection

- a. Building an adjacent structure that the elevator can ‘lean’ against. The imposed lateral loads are approximately 1,000/foot (40,000 in the north/south direction; 50,000 in the east/west direction), which are not unreasonable for an adjoining building to resist. *(12/12/2013 revision: The construction of a second building, as described in this recommendation, will eliminate recommendation 5b below: the requirement for the four concrete buttresses against the elevator west wall.)*
- b. The second solution includes installing diagonal steel rod braces in two bays along each exterior wall (8 exterior bays) and two interior bays in each direction (4 interior bays). The braces would likely be 1” - 1 ½” diameter steel rods with turnbuckles and fabricated steel sleeve attachments to the columns above and below. These could be designed to match the historic elevator aesthetic.

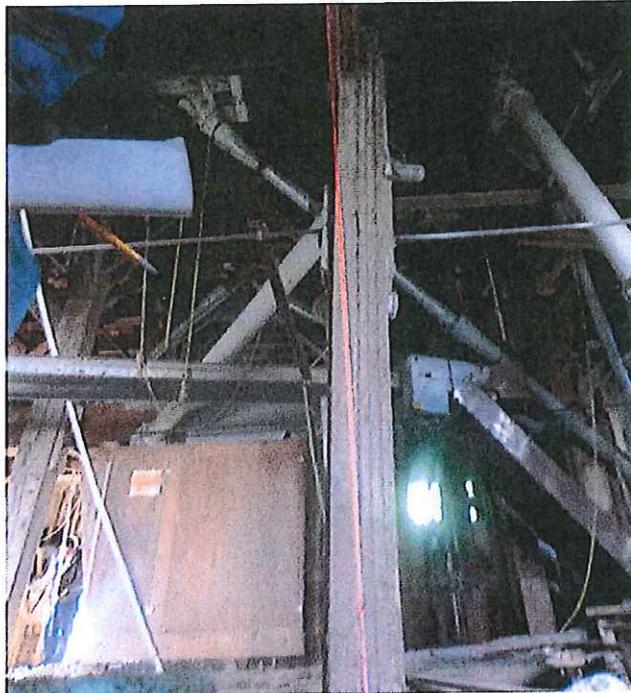
Photo 8: Interior column showing southward deflection

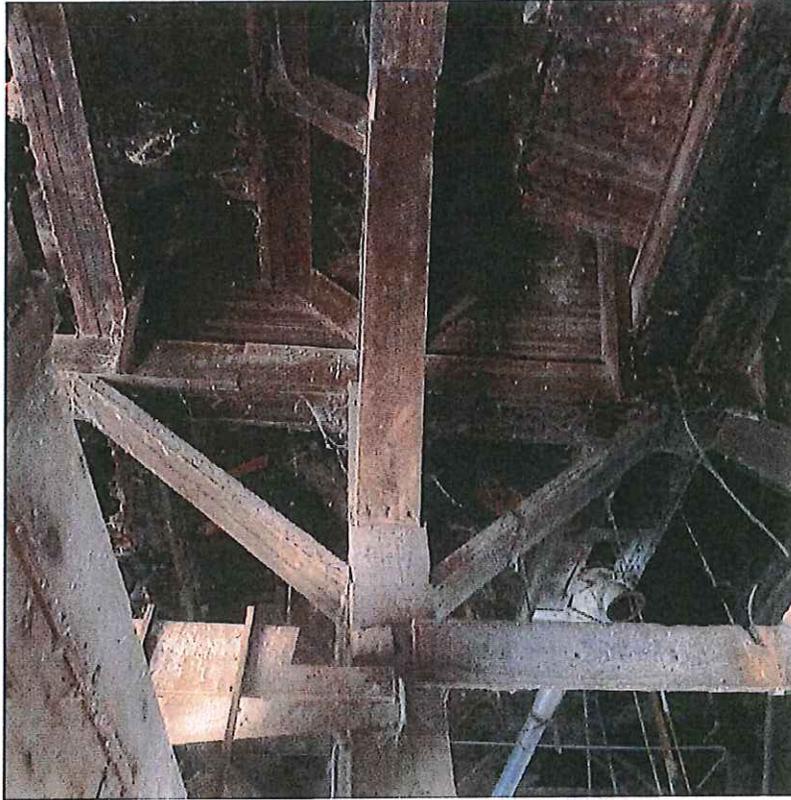
Photo 10: Close-up of knee-brace at top of column

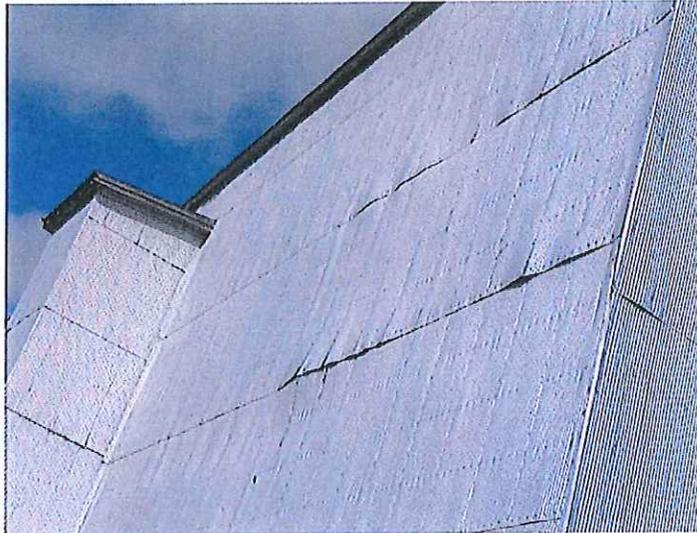
from the bottom of the bins down to the foundation through the corrugated metal exterior walls. These act as stiff vertical shear walls that resist rotation and allow the wind forces to flow down to the foundation. See photo 11.

Photo 11: Corrugated steel cladding
