**Sturgeon Bay**  
Door County, Wisconsin  
**Aquatic Plant Management Plan**  
February 2024  
**Official First Draft of Agency and Public Review**

Created by: Tim Hoyman and Josephine Barlament  
Onterra, LLC  
De Pere, WI

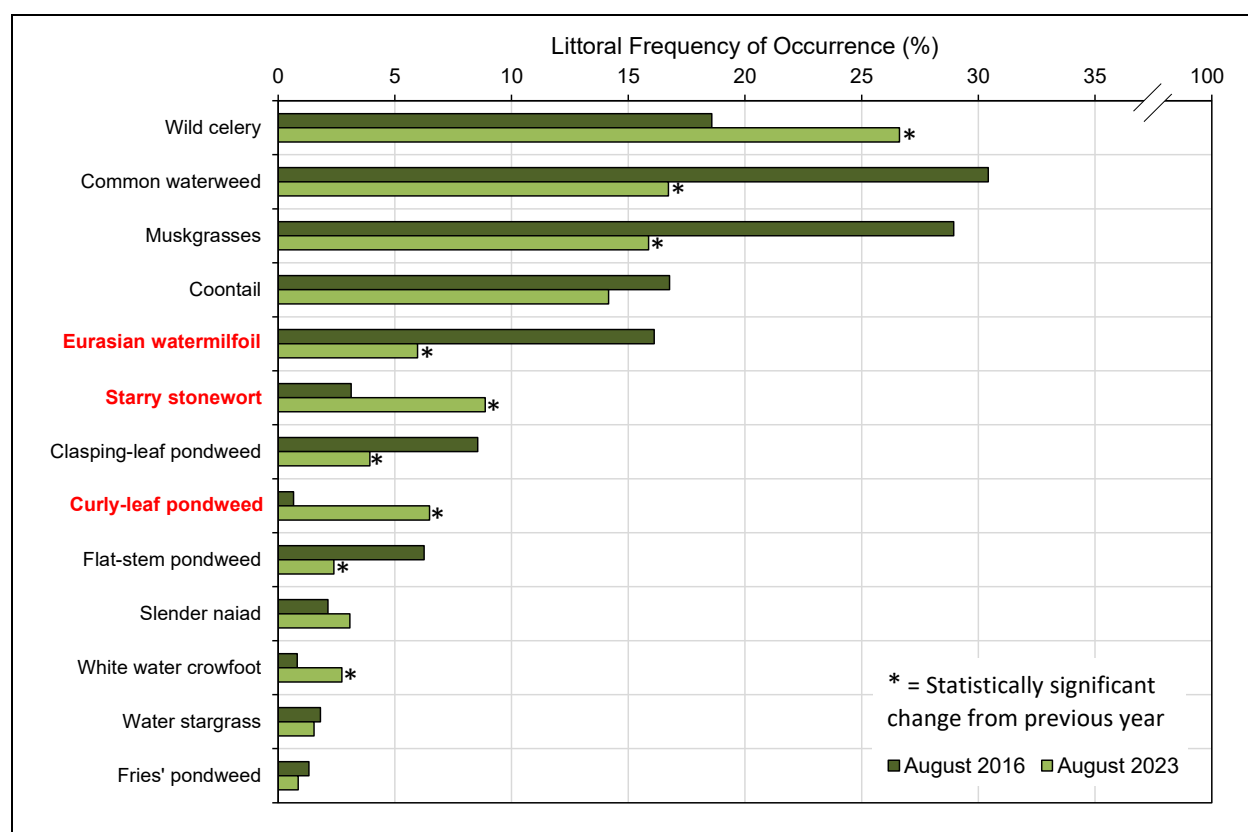
**Figure 3.2-2. Littoral frequency of occurrence of aquatic plant species in August 2016 and 2023.** Exotic species indicated with red.

Of the 34 aquatic plant species located during the 2023 surveys, 23 species were physically sampled on the rake during the August point-intercept survey and the remaining 11 species were located *incidentally*. An incidentally-located species means the plant was not directly sampled on the rake during the point-intercept survey but was observed in the lake by Onterra ecologists and was recorded/collected. The majority of incidentally-located plants typically include emergent species growing along the lake’s margins and submersed species that are relatively rare within the lake’s plant community. Of the 23 species encountered on the rake in August 2023, wild celery, common waterweed, muskgrasses, and coontail were the four most frequently encountered (Figure 3.2-2).

Common waterweed, the second most frequently encountered aquatic plant, with a littoral frequency of occurrence of approximately 16.7%, is found throughout lakes in Wisconsin and North America. It prefers growing in soft sediments and can often grow in dense beds that mat on the surface. In Sturgeon Bay, it was encountered between 2 and 19 feet of water. Its dense foliage provides valuable aquatic habitat while its ability to derive nutrients directly from the water improves water quality.

Muskgrasses, the third most frequently encountered aquatic plants in Sturgeon Bay had a littoral frequency of occurrence of approximately 15.9% (Figure 3.2-2) and were abundant primarily between 2 and 10 feet of water. A genus of macroalgae, muskgrasses are not true vascular plants, and are often abundant in waterbodies that are clear with higher alkalinity. While several species of muskgrasses occur in Wisconsin, the muskgrasses in Sturgeon Bay were not identified to the species level. Often growing in dense beds, muskgrasses stabilize bottom sediments, provide excellent structural habitat for aquatic organisms, and are sources of food for fish, waterfowl, and other wildlife (Borman, 2007).

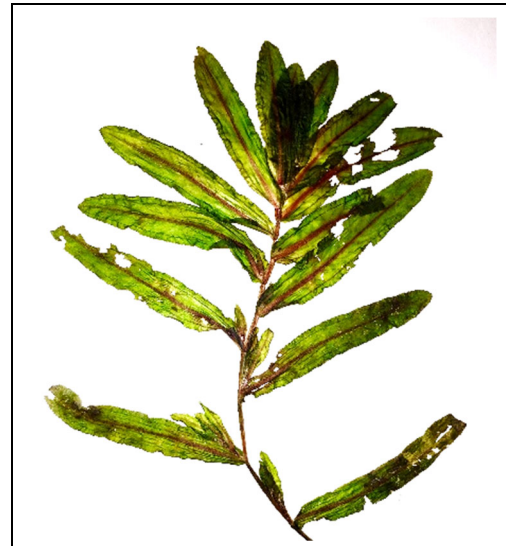
**Photograph 3.3-1. Curly-leaf pondweed, a non-native, invasive aquatic plant.** Photo credit Onterra.

Curly-leaf pondweed (CLP) (Photograph 3.3-1) is a European exotic first discovered in Wisconsin in the early 1900's that has an unconventional lifecycle giving it a competitive advantage over our native plants. Curly-leaf pondweed begins growing almost immediately after ice-out and by mid-June is at peak biomass. While it is growing, each plant produces many turions (asexual reproductive shoots) along its stem. By mid-July most of the plants have senesced, or died-back, leaving the turions in the sediment.

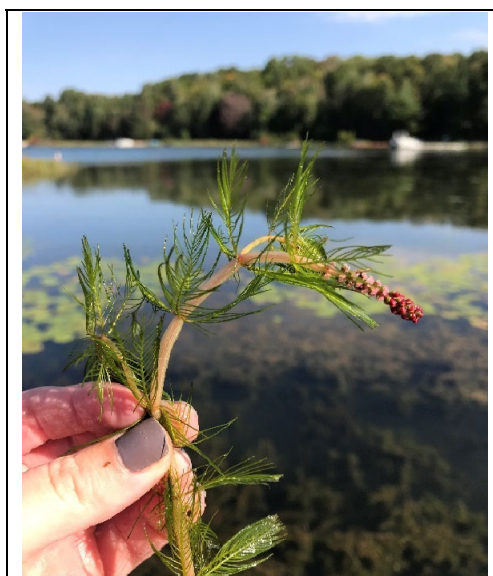
**Photograph 3.3-2. Eurasian watermilfoil, a non-native, invasive aquatic plant. Photo credit Onterra.**

One of the submersed non-native aquatic plants known to be present within Sturgeon Bay Eurasian watermilfoil (EWM). Eurasian watermilfoil is an invasive species, native to Europe, Asia and North Africa, that has spread to most counties in Wisconsin (Photograph 3.3-2). Eurasian watermilfoil is unique in that its primary mode of propagation is not by seed. It actually spreads by shoot fragmentation, which has supported its transport between lakes via boats and other equipment. In addition to its propagation method, EWM has two other competitive advantages over native aquatic plants: 1) it starts growing very early in the spring when water temperatures are too cold for most native plants to grow, and 2) once its stems reach the water surface, it sometimes does not stop growing like most native plants and instead continues to grow along the surface creating a canopy that blocks light from reaching native plants.

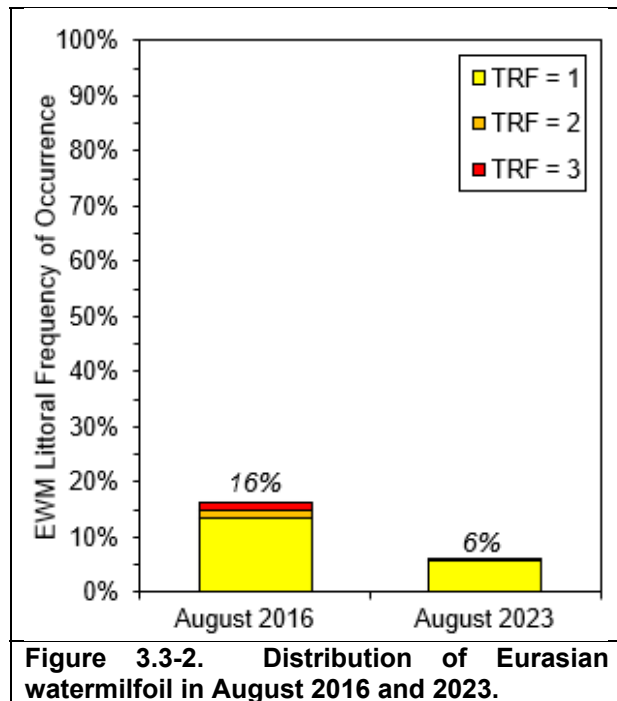
**Figure 3.3-2. Distribution of Eurasian watermilfoil in August 2016 and 2023.**

Unlike CLP, EWM reaches its peak growth in mid- to late-summer, and assessments are usually completed in July through September to capture populations at their peak. Figure 3.3-2 and Map 5 illustrates the distribution of EWM in the study area of Sturgeon Bay as determined from the point-intercept surveys in August of 2016 and 2023 completed by Onterra. During these surveys, EWM had a littoral frequency of occurrence of approximately 16% in 2016 and 6% in 2023. It was most abundant between 4 and 14 feet of water. Total rake fullness data indicates the majority of the point-intercept sampling locations that contained EWM had an EWM total rake fullness rating of 1 for both years. Onterra ecologists did note EWM growing within some of the marinas. While EWM is widespread throughout the study area, in most locations it is not overly dense and likely not creating any navigational issues.

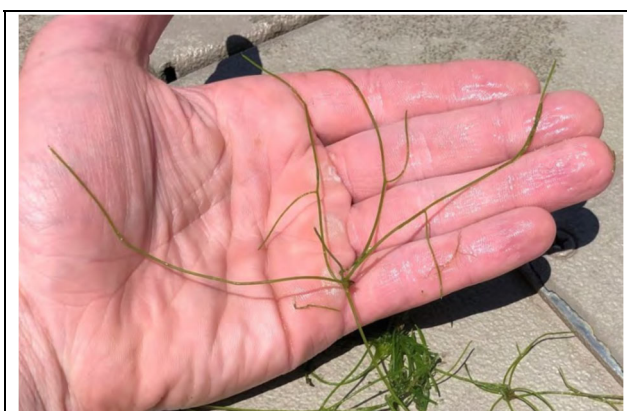
**Photograph 3.3-3. Starry stonewort, a non-native, invasive macroalgae.** Photo credit Onterra.

Starry stonewort (*Nitellopsis obtusa*; SSW; Photograph 3.3-3) is a non-native, invasive macroalgae that was first observed in the United States in 1978 within the St. Lawrence River. It was recently discovered in a southeastern Wisconsin lake in 2014, and has since spread to approximately two dozen inland lakes within 10 counties in Wisconsin. The discovery of starry stonewort in Sturgeon Bay in 2016 marks the first record of its occurrence in Lake Michigan.

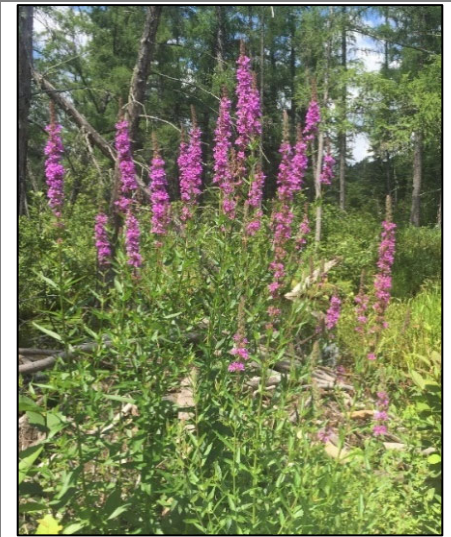
**Photograph 3.3-4. The non-native wetland plant, purple loosestrife.**  
Photo credit Onterra.

Purple loosestrife is a perennial, herbaceous wetland plant native to Europe and was likely brought over to North America as a garden ornamental (Photograph 3.3-4). This plant escaped from its garden landscape into wetland environments where it is able to out-compete our native plants for space and resources. First detected in Wisconsin in the 1930's, it has now spread to nearly the entire state. Purple loosestrife largely spreads by seed, but can also spread from root or stem fragments.
